# The PzKpfw V PANTHER

*Text by* BRYAN PERRETT

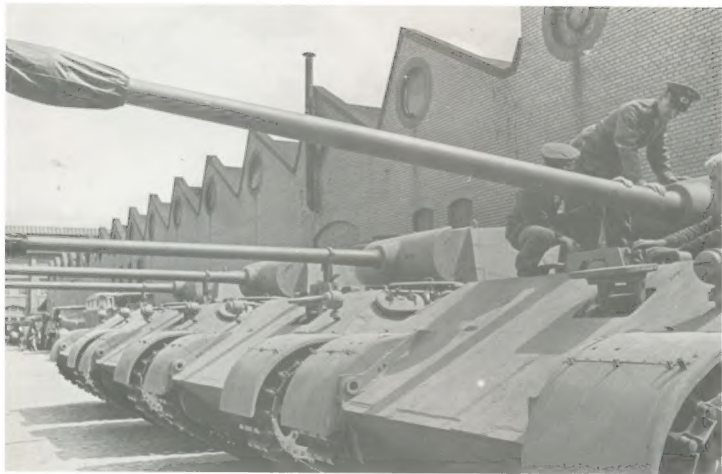
The Panther Ausf. D's glacis incorporated a vision hatch for the driver and a hinged flap for the hull machine-gun. When both were closed it presented a smooth appearance. (Martin Windrow)

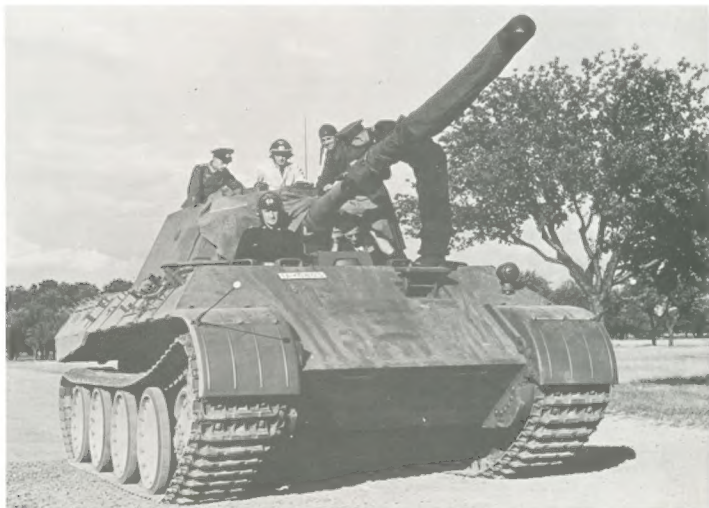
**Panzer personnel enjoy a demonstration run in one of the first models built. Details of the gun have been deliberately concealed from photographers by means of a bulky jacket; the mantlet, too, is shrouded under a tarpaulin. (Martin Windrow)**

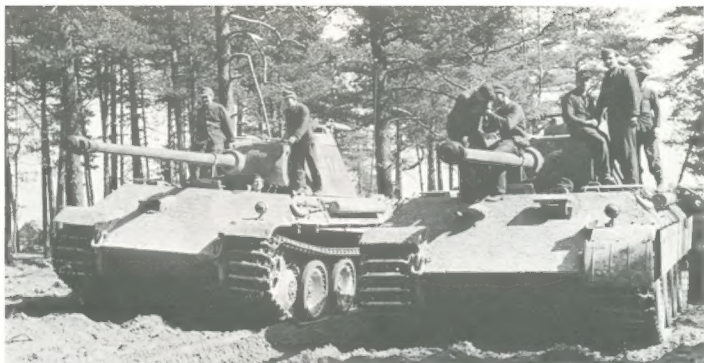
The Ausf. G (left) can be distinguished from the Ausf. A (right) by the absence of the driver's vision hatch in the glacis, and by the less sharply angled hull sides. The side cylinders contain the gun's barrel scrubber, which could be broken down into several lengths for stowage. (Bundesarchiv)

The last production model was the **Ausf. G**, which appeared in the spring of 1944. On this version construction had been simplified and internal space gained by fixing the upper-hull side plates at a less oblique angle, but the vehicle was more easily recognised by the absence of the driver's vision hatch in the mantlet, this being replaced by a rotating episcopes in the roof of the driving compartment. In addition the driver's and operator's swinging pivot access hatches were replaced by a hinged type, the opening of which was assisted by internal springs. Late models were fitted with resilient steel road wheels and a new mantlet which avoided the downwards-deflection dangers of the earlier rounded type by being thickened at the base.

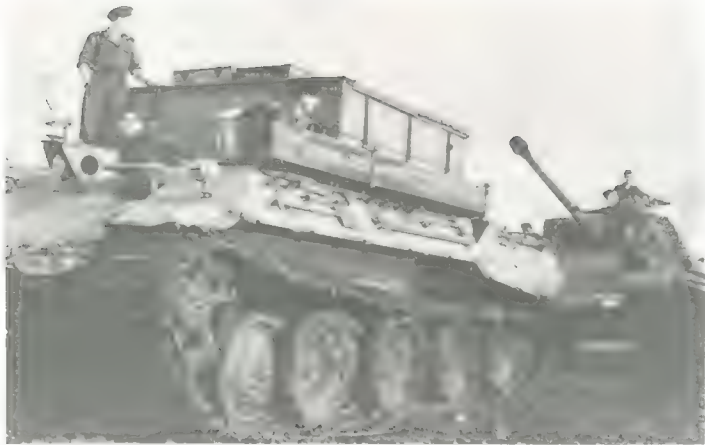
*Bergepanzer* (armoured recovery vehicle) version of the Panther taking the strain. Army Group South sector, 1943-44. (Bundesarchiv)

One hundred and sixty gallons of fuel were carried (236 by the *Bergepanzer* version), contained in five inter-connected tanks, one against the rear wall of the engine compartment and two on each side. These were filled through a common pipe entering the rearmost tank. Fuel consumption varied between 1.40 gallons per mile during road use and 2.66 gallons per mile across country. An oil change was required every 250kms when running and thereafter every 2,000kms unless operating in dusty conditions, when a change was required every 1,000kms.

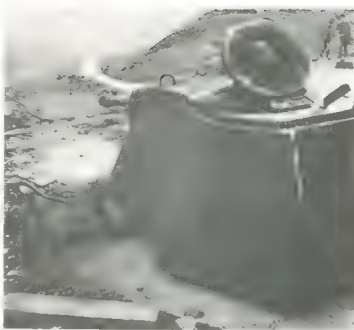
Panther ground turret, carefully sited to cover a blind bend on a mountain road. Gothic Line, Italy, 1944. (Imperial War Museum)

A further development involving the Panther was the **Ground Turret**, which was encountered in Italy at both the Hitler and Gothic Lines.<sup>1</sup> This consisted of the standard Panther turret and its armament – less the power traverse mechanism and the cupola – mounted on top of a rectangular steel box which had been dug into the ground. The box consisted of two portions, the upper being 10ft 11 in. long, 9ft 3½ in. wide and 3ft 2½ in. high, the top plate incorporating the turret ball-race and the floor a manhole located over an iron ladder leading down into the lower portion; this

conformed to the dimensions of the structure above, but was 6ft 7in. high and was divided into three compartments. One, lined with board, contained three bunks for the crew and an escape manhole; the second the main access hatch and the ladder; and the third was a storeroom for food and ammunition and also contained electric batteries and a switchbox. Electric light was provided, and fans in the roof dispersed fumes. The whole pillbox was sunk into the ground to within a foot of the top of the upper section, and the spoil was built up to the base of the Panther turret and smoothed off in a long sloping ramp. The main access started about 40 feet away and consisted of a slit trench sloping fairly sharply downward and covered at its deeper end with wooden beams and earth.

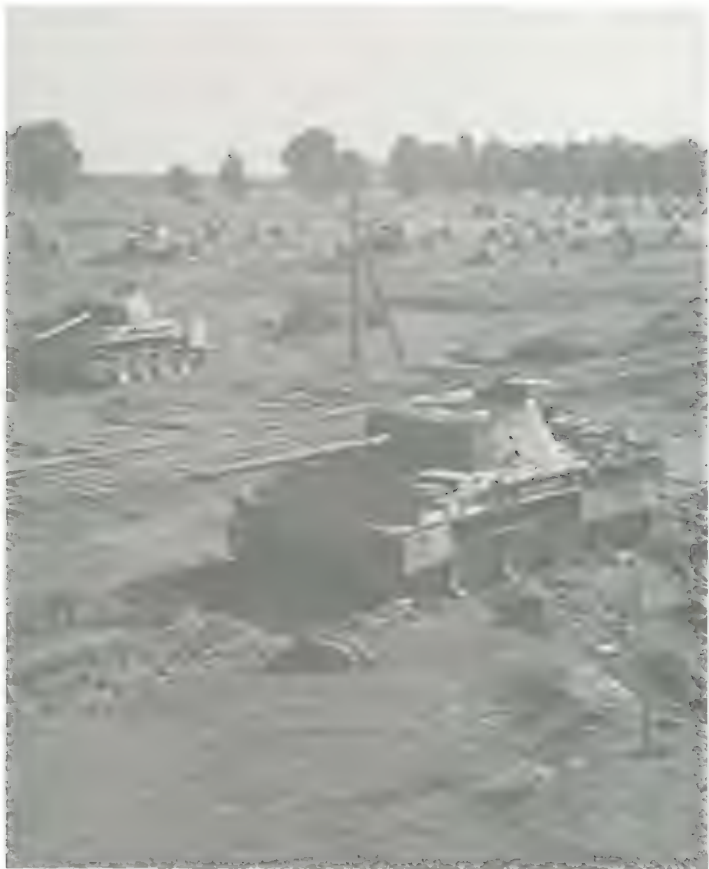
The Panther's early combat experiences were far from happy. At least six litter this summer 1943 tank killing ground in the Ukraine, abandoned by their crews. On the nearest vehicle the turret pistol port-plug has been pushed out and is hanging by its chain. (Novosti)

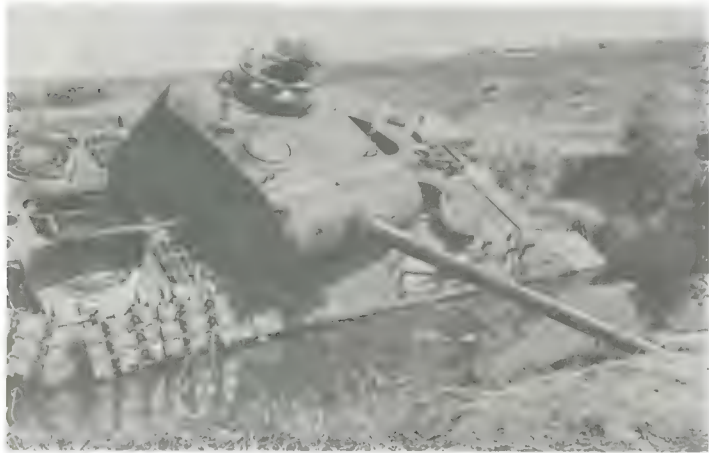
The river bank has collapsed beneath this Ausf. A while it was engaging a target to the right; had the gun not buried itself, the vehicle might possibly have rolled. (Novosti)

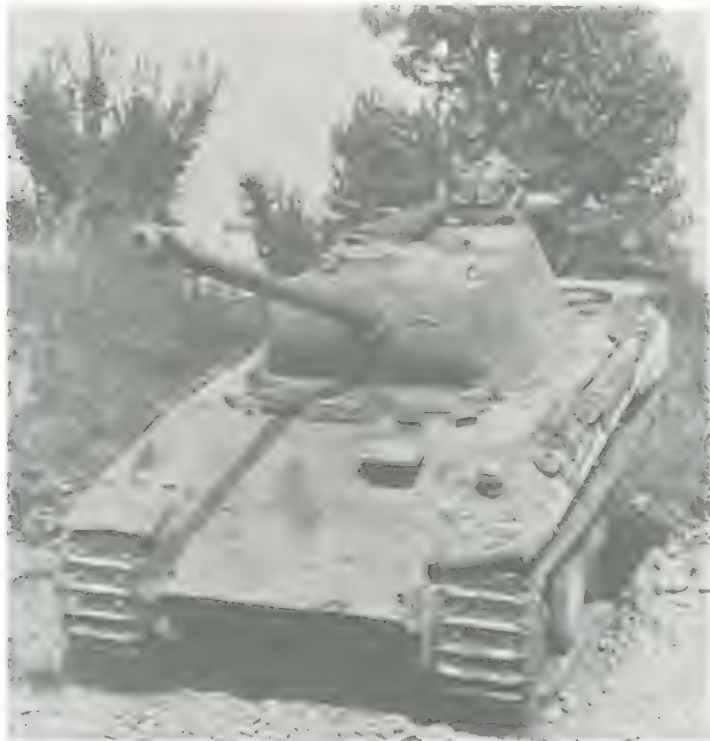
Long guns present a problem when descending a steep slope. If the muzzle strikes the ground at the bottom the mounting may sustain serious damage so, as in this case, the gunner applies elevation until level going is reached. The vehicle is an Ausf. D, probably belonging to 16. Panzer-Division, which served in Italy in 1943. (Martin Windrow)

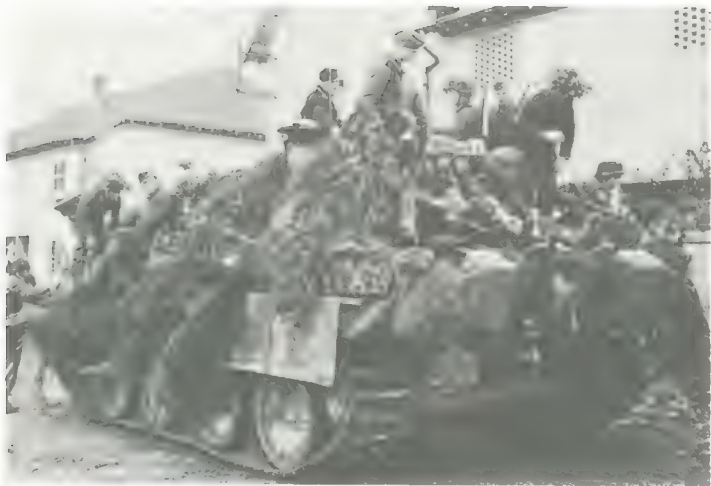
This crew have made effective use of evergreen and deciduous boughs to break up the outline of their vehicle and mask its hard texture. Evergreen was easier to use and lasted longer, but could look oddly out of place if used alone. On the other hand deciduous camouflage had to be replaced as soon as the leaves died back, although it looked more natural. The grenadiers have a fresh, spruce look which suggests a lift into, rather than out of, action. France, September 1944. (Bundesarchiv)

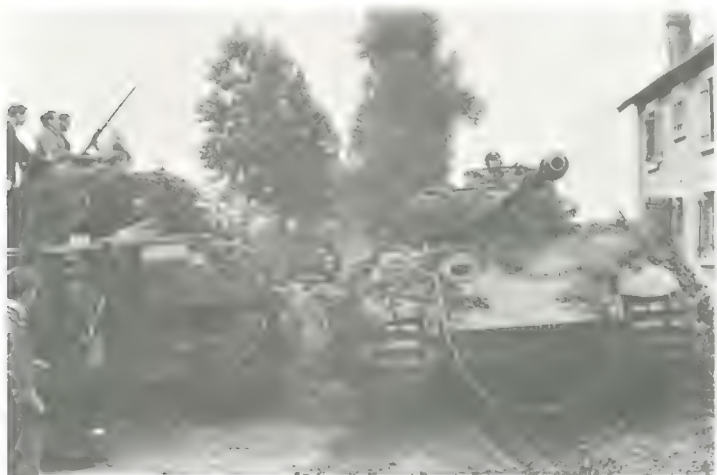
Right, an Ausf. G in a hurry passes two Panthers halted at the roadside, France, September 1944. The manned AA mounting and the towing hawser, shackled ready for use, epitomise the Panther's experience during the retreat from Normandy. (Bundesarchiv)

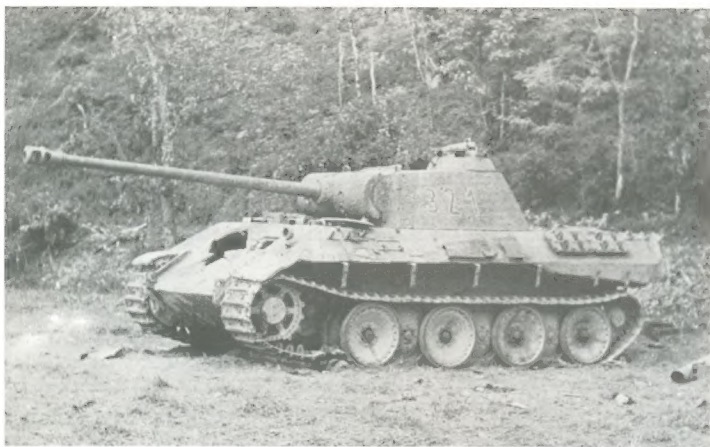
The effect of an HE T105 anti-concrete round when fired at close range at the glacis of a Panther Ausf. A. (RAC Tank Museum)

Shermans and M10 tank destroyers, two penetrations of the driving compartment roof being obtained at 800 yards with APC ammunition. The APC round failed to penetrate the glacis at this range, as did the HE T105, which had been designed for use against concrete, although the HEAT round succeeded. Use of standard AP ammunition against the hull side did not result in a penetration until the range had been closed to 200 yards, but with APC the Sherman penetrated the 45mm turret side armour at 800 yards and the M10 sent a round straight through. The HEAT round was equally effective against the turret and the HE T105 blew a hole in the plating.
